**CANADIAN FORCES
FLIGHT SAFETY INVESTIGATION REPORT (FSIR)
FINAL REPORT**

FILE NUMBER: 1010-C-GFME (DFS 2-3-3)
DATE OF REPORT: 25 July 2006

AIRCRAFT TYPE: Schweizer 2-33A Glider
DATE/TIME: 31 2132Z July 2003
LOCATION: Central Region Air Cadet Gliding School, Picton, ON
CATEGORY: "A" Category Accident

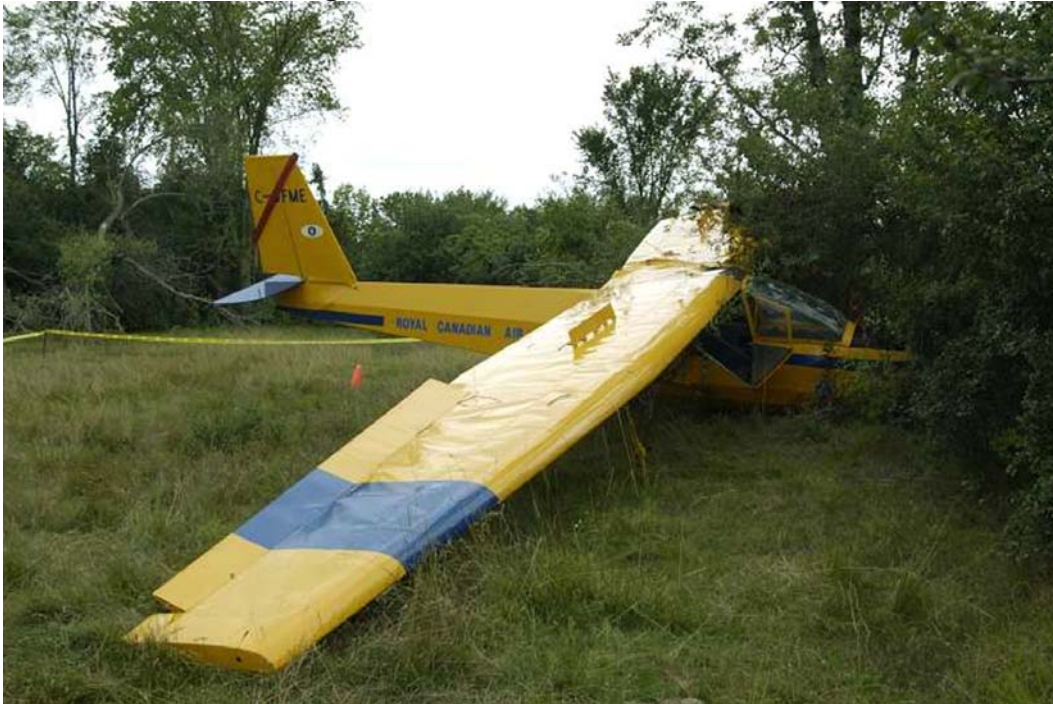
Photo 1: Final Resting Place

The glider sustained "A" category damage (Photo 1).

The wreckage was located on the edge of a small field outside of the Picton airfield boundary and approximately 250 meters from the departure end of runway 17. Due to the slow airspeed at the time of impact, the wreckage was contained in and around the base of the tree that the left wing initially struck; there were no indications of other impact sites or ground scarring. The field was bordered by a wooden fence and contained a herd of cattle. A portion of this fence was removed in order to gain site access and to facilitate glider removal.

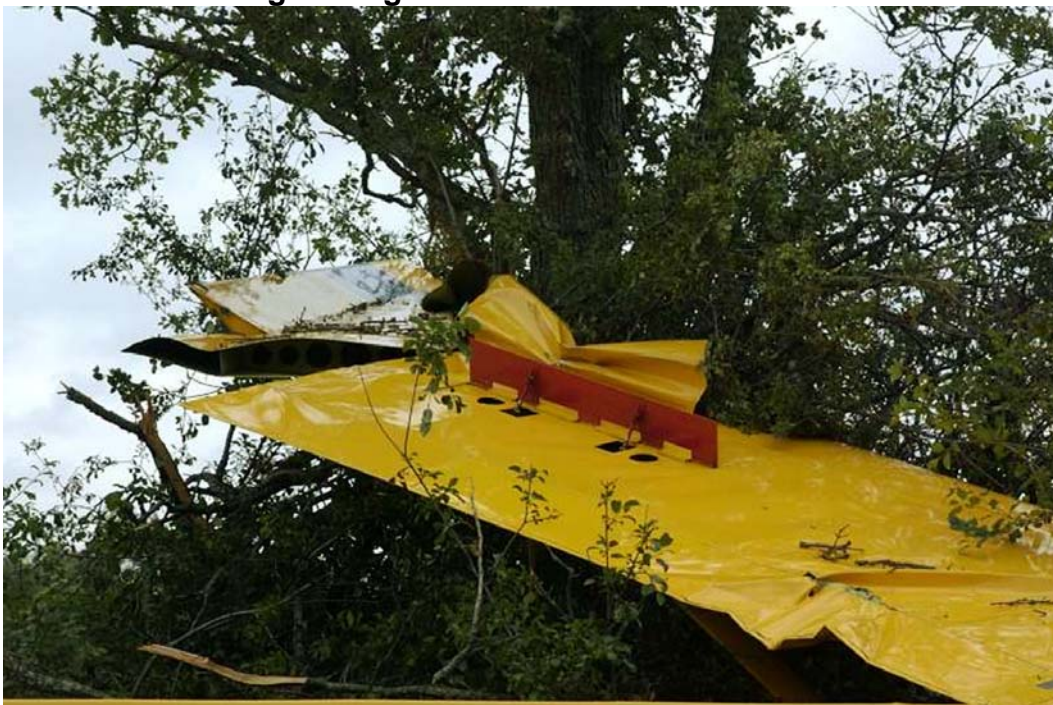
Photo 2: Left Wing Damage

The left wing suffered extensive damage (Photo 2): the midpoint of the leading edge struck the tree first and, as the glider then pivoted around the tree, the leading edge was peeled away from the wing radially outwards from the initial impact point and the outboard section of the wing was folded forward in the

horizontal. The right wing exhibited severe skin deformation. Flight control surfaces on both wings were seized as a result of impact forces. The cockpit remained intact and undamaged. Minor cracking of the overhead cockpit canopy was noted. The forward canopy could not be opened during the egress. Numerous punctures of the glider's skin were noted. Deformation of the skin and longerons was also evident in the tail section.
